FRENCH RIVER BASIN  
CHARLTON, MASSACHUSETTS

LITTLE NUGGET LAKE DAM  
MA 00103

**PHASE I INSPECTION REPORT  
NATIONAL DAM INSPECTION PROGRAM**

OCTOBER 1978

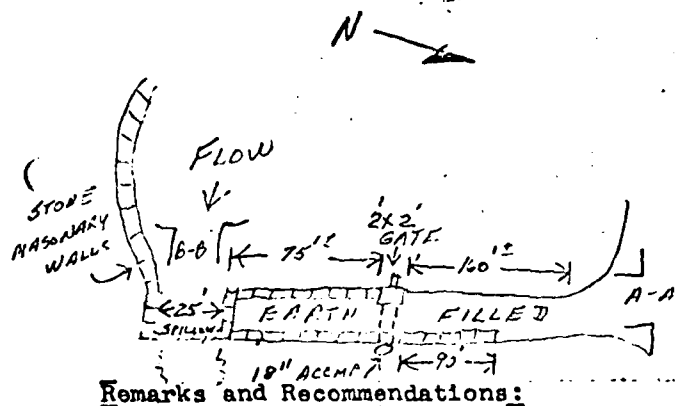
STONE MASONRY WALLED DOWNSTREAM, PATTERN STONE  
RIP RAP UPSTREAM, EARTH FILLED, GATE OPERATABLE  
5 YEARS OLD, 2'x2' GATE, PETS. 18" APPROX.  
4"X12" FLASHINGS,  
 Sketch (Not to Scale):
